CAP 661

Mandatory Permit Directives

For Aircraft Operating on a Permit to Fly

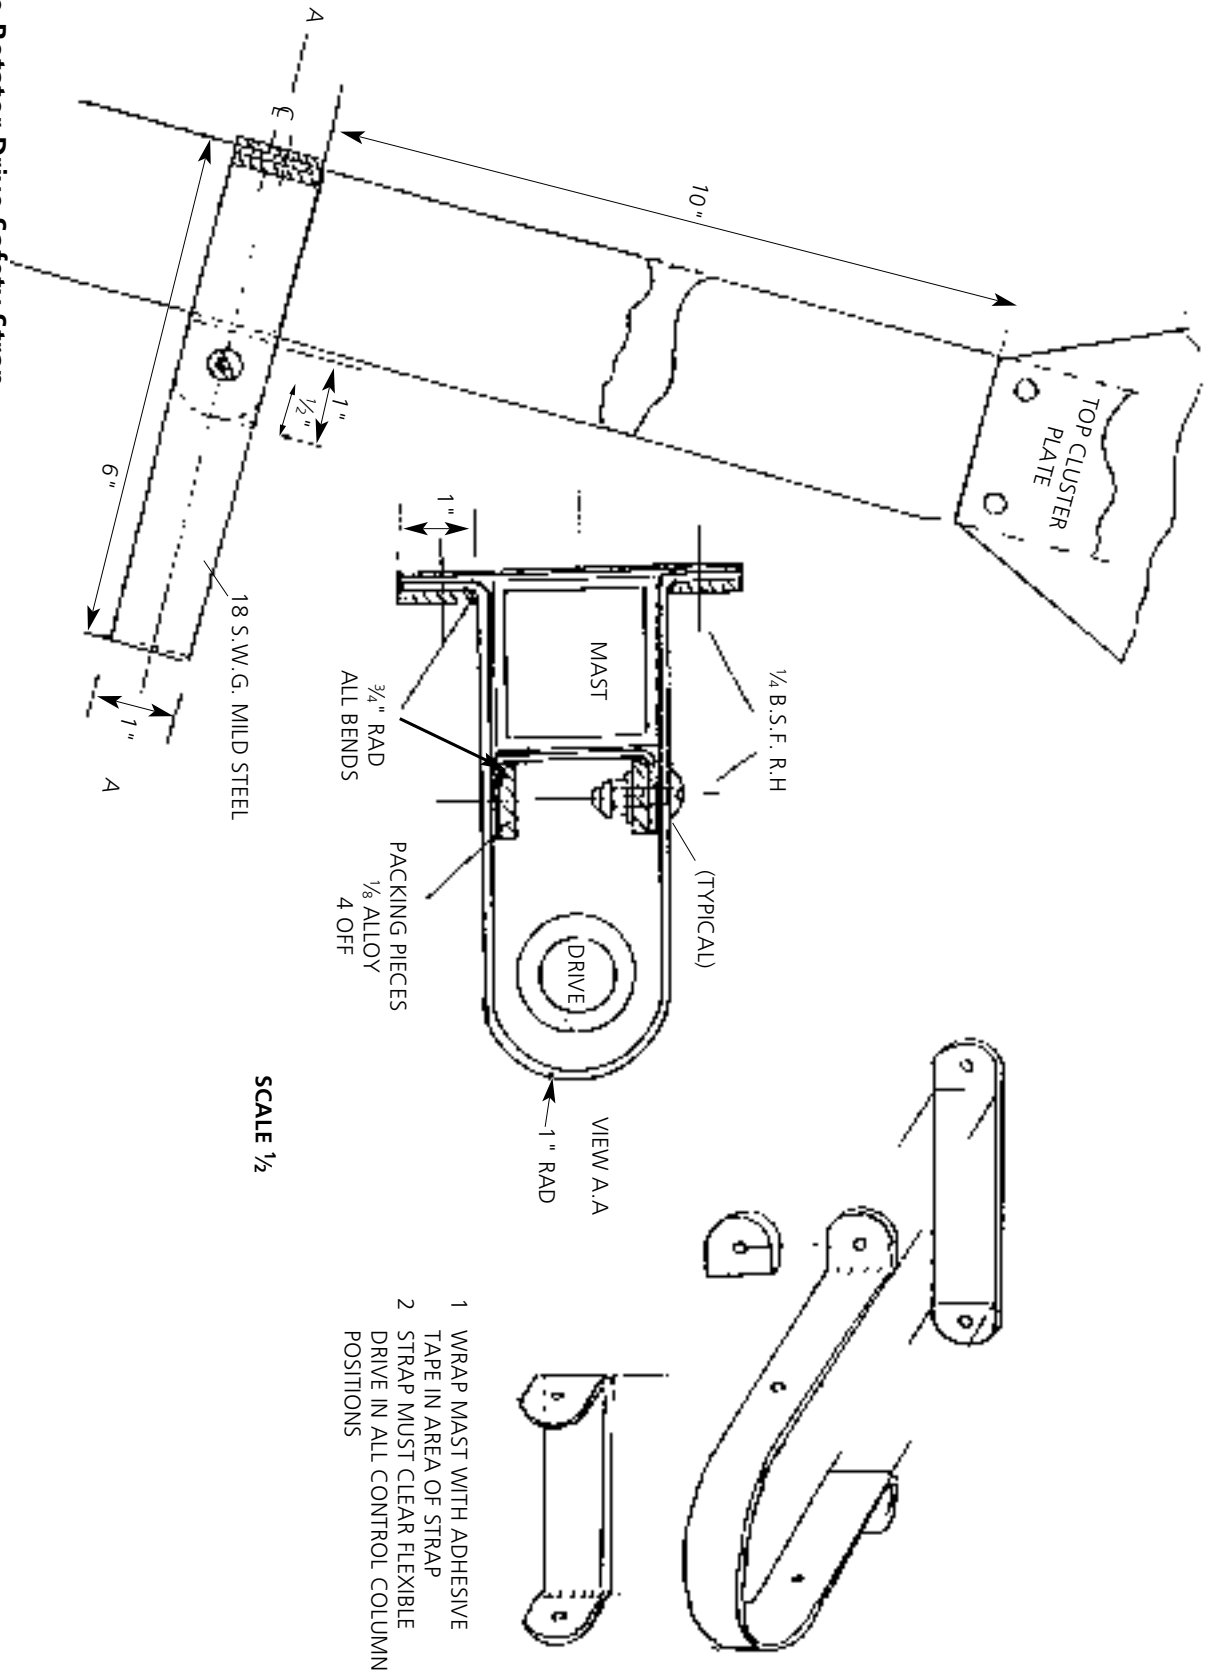
Figure 4 Pre-Rotator Drive Safety Strap

- 2 Check that the flexible drive shaft is correctly restrained in position on the aircraft by a safety collar mounted on the rotor pylon positioned approximately 10" below the rotor head cluster plates. (See Figure 3). This safety collar is a loose fit around the shaft which must be able to move freely up and down as the flying controls are moved. (See Figure 4).

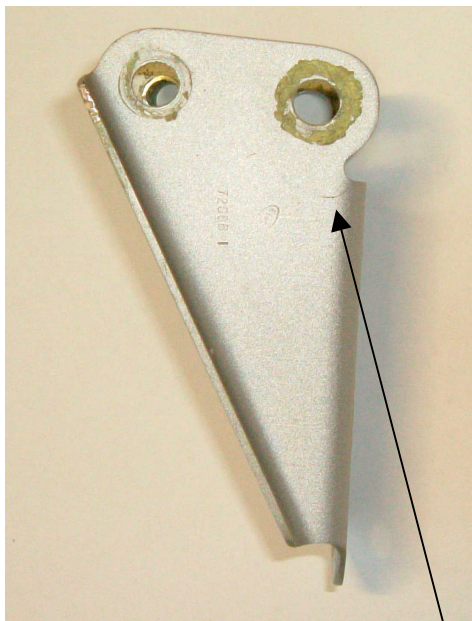
Reason: Cracks have been found in the engine mounting brackets of three Hurricane aircraft. A pair of brackets is installed on each side of the engine mount. The photographs below show the location of the cracks.

Location of
cracks

A 72086 bracket showing the location of
cracking
