CAP 661

Mandatory Permit Directives

For Aircraft Operating on a Permit to Fly

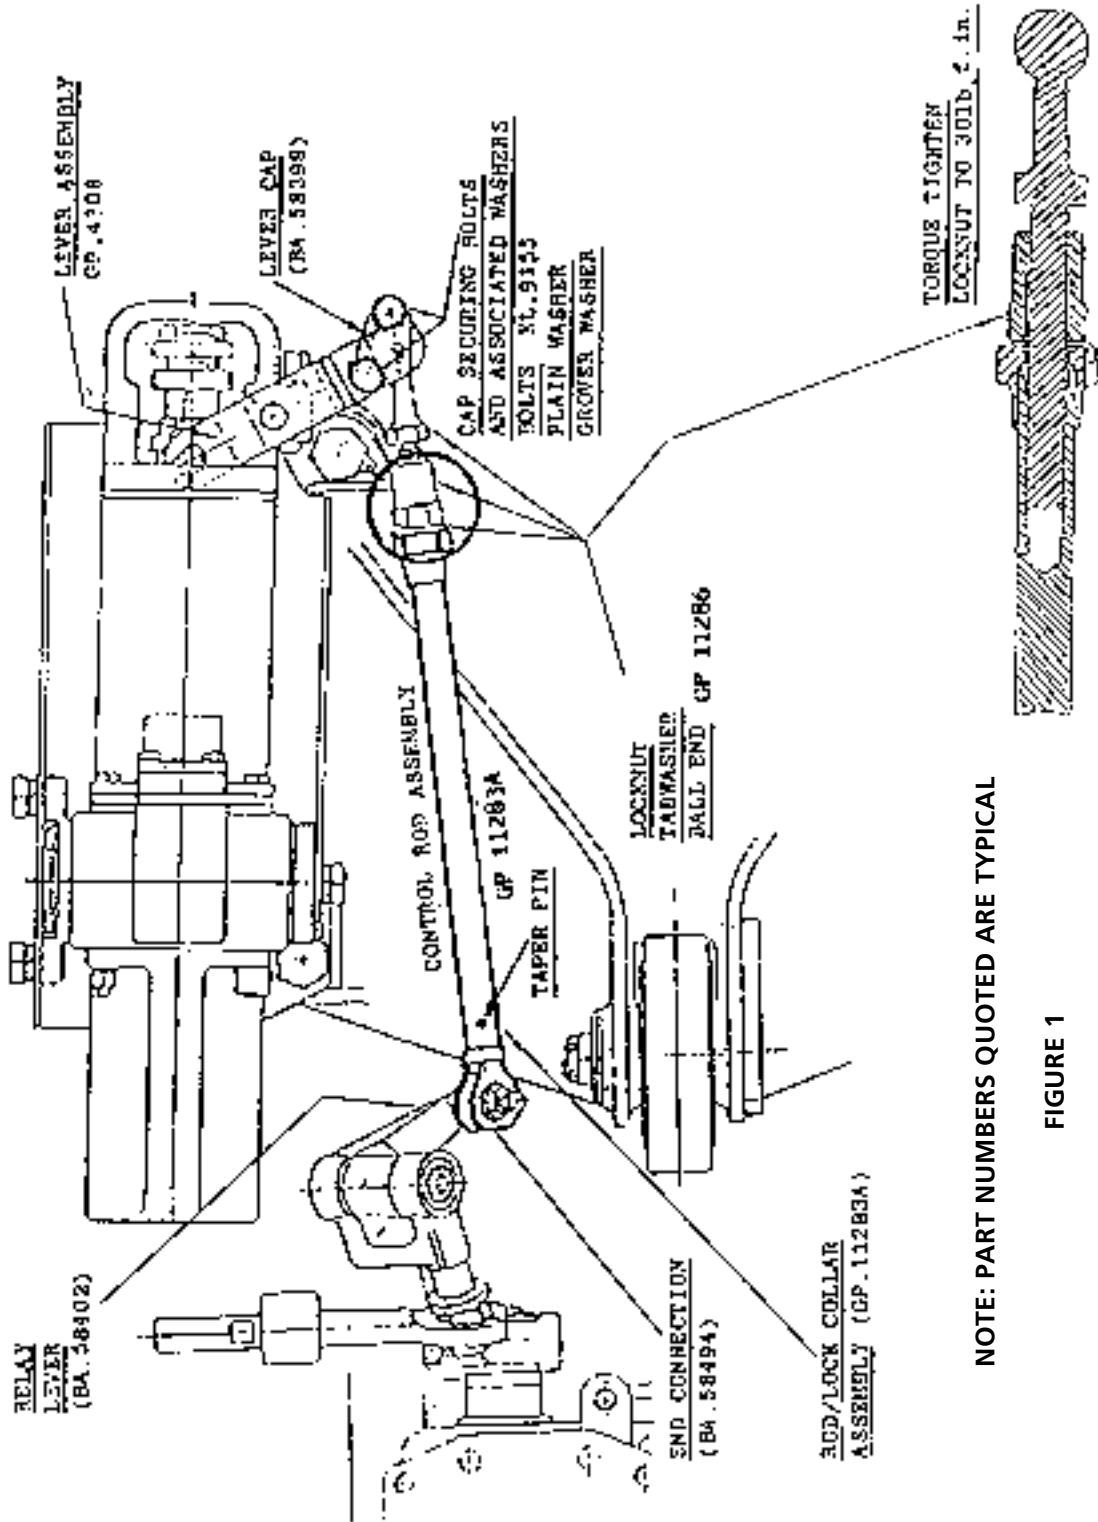
FIGURE 1

TOP TEMPERATURE CONTROL LINKAGE
